# Identifying Locations for Best Management Practices in the Middle Fork Whitewater River Sub-Watershed Using the Agricultural Conservation Planning Framework Tool

Christopher Hood

*Department of Resource Analysis, Saint Mary's University of Minnesota, Winona, MN 55987*

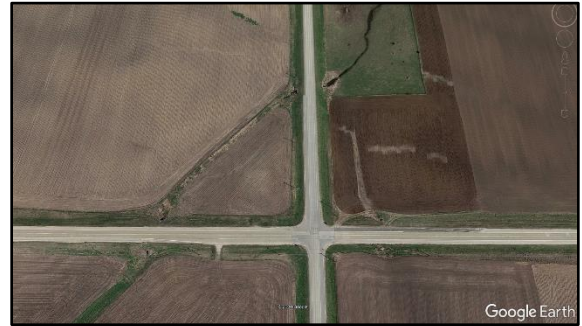
Figure 3a. Aerial imagery obtained from Google Earth to verify culverts allowing water to flow under roads.

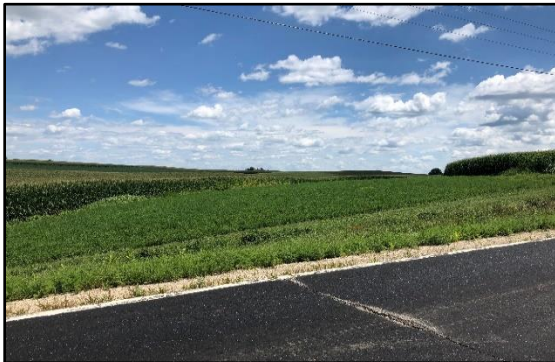
Image 1. Contour buffer strip near the intersection of Rt. 39 and Rt. 108 north of Saint Charles in one of the high risk fields.

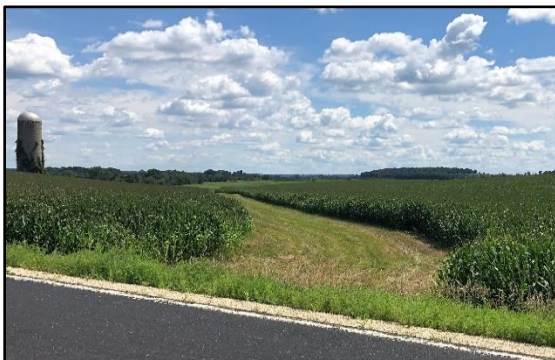
Image 2. Grassed waterway along 10<sup>th</sup> St SE just north of Saint Charles in one of the high risk fields.

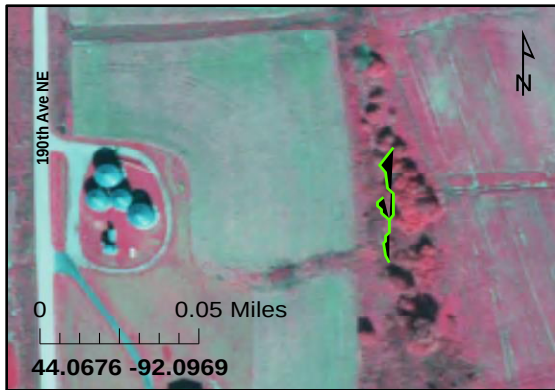
Figure 9. The single location that did not line up with an existing grassed waterway. This was excluded because it was proposed within a tree line. The proposed site appears in green.

The location of the singled out grassed waterway without an already

existing waterway is located to the east of 190th Ave NE in Saint Charles (Figure 9). The proposed location was actually located within a tree line along a field boundary. Technically, it was not located on an existing traditional grassed waterway, so it was not included in the existing grassed waterway count.

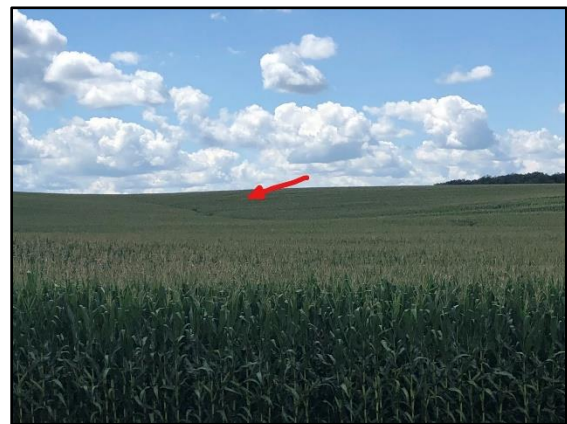
Image 3. Gully erosion present within a “Low” risk assessed field west of Rt. 74 just north of Saint Charles. The red arrow points out the evidence of a future erosion issue. A grassed waterway could potentially prevent the issue.

sites, the presence of gully erosion became evident in one particular area west of Rt. 74 (Image 3, Figure 14). The area was found to be located within a “Low” runoff risk assessment field in the data. However, it did not show up as a proposed site within the Grassed Waterways Tool results. The tools only suggest sites, but knowing the areas and evaluating the sites with a field visit is just one of the next steps in a project like this. It cannot be stressed enough that the toolbox is supposed to be used along with knowledge

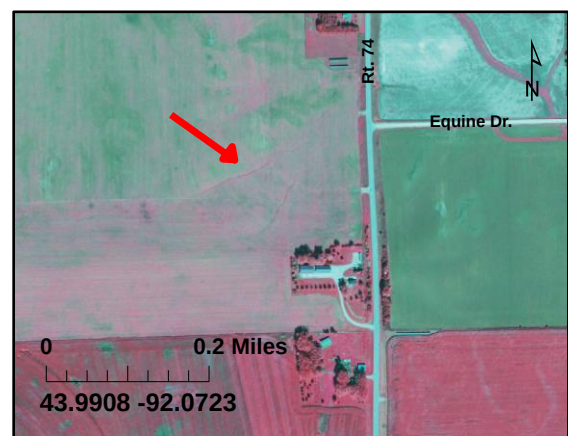
Figure 14. Aerial image of the erosion present with in the “Low” runoff risk assessed field from Image 3. The red arrow is the gully erosion from the photograph.

The erosion witnessed from the field verification in Figure 14 was from a road-side photo. Conducting road-side verification or field checks for erosion or BMPs were not as easily viewed from the road. Some of these fields are vast and hidden among tree lines. It is never a good idea for someone to wander off onto the property of someone else. A drone would have been a great way to get the vantage point or angles needed for usable verification images. Even the use of drones along the highway may cause problems among the landowners so it is always best to communicate with them and ask for permission before attempting any sort of drone use.
