Enhancing Wastewater Utility Mapping and Flow Line Analysis with Geographic Information Systems (GIS)

Department of Resource Analysis, Saint Mary's University of Minnesota, Winona, Minnesota, 55987

This study was designed to locate problematic structures and current areas that are in need of rehabilitation. This utility mapping study was conducted on a city located in Western Iowa that has a population of approximately 2,368 as of the 2000 census, covered 4.9 square miles (Anonymous, n.d.). The study was comprised of locating sanitary sewer

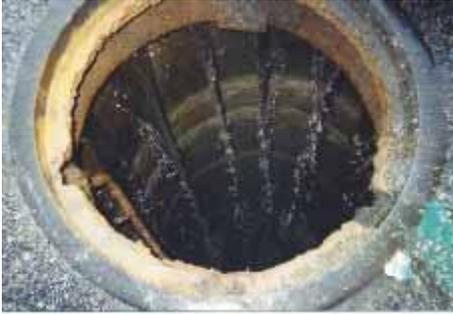
Figure 1. A manhole in very poor condition with a very high infiltration rate with cracks in the walls. This manhole would have been given a rank of “one” for condition due to the size of the cracks and a “five” for infiltration rate based on the amount of water potentially entering the structure. This structure would have been scheduled for replacement as soon as possible.

Moderate infiltration was quantified as an amount that would not drastically increase the amount of water being distributed to the wastewater treatment plant immediately, but if it does not subside then damage could occur. A rank of “four” meant there was an infiltration rate between moderate and heavy, and a rank of “five” meant that the infiltration potential was heavy. Ranking for the upper end of moderate to heavy were quantified as an amount of water that would have an impact on the wastewater treatment process. There was not a specific numeric value set for the quantification of infiltration. The assessment was in the judgment of the survey technician based on the number and size of the cracks in the structure, and the amount of water that can be seen

entering the structure through the damaged area (Figure 1).

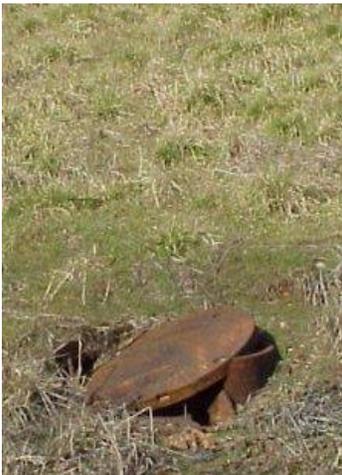
Figure 2A. Existing manhole with a broken lid and insufficient casting.

Structural defects define manholes that have physical deficiencies such as a broken lid, crumbling brick, or insufficient casting (Figures 2A and 2B). Defects were not ranked; they were noted in the attribute table for repairs. These defects were specifically listed per structure in the attribute table in ArcGIS.

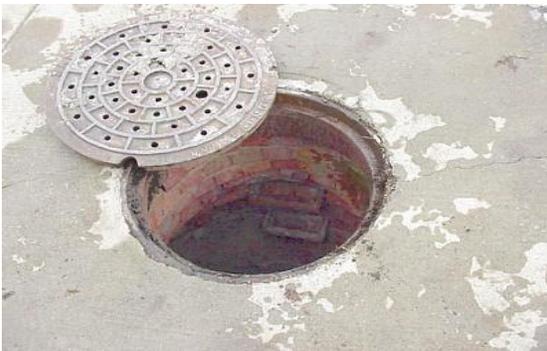
Figure 2B. Existing manhole with crumbling brick.

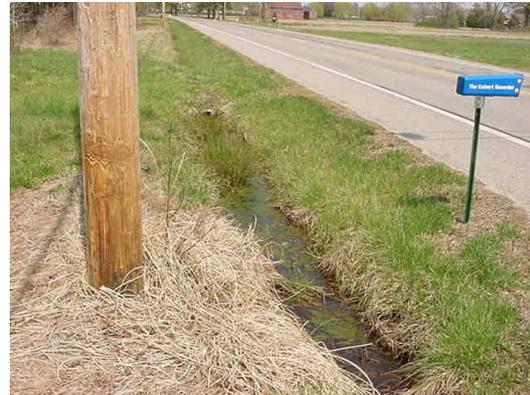
Figure 3. Here ditches are used for drainage along roadways.

The reason it was essential to locate manholes located in ditches was because a manhole that is located in a ditch is prone to higher infiltration potential due to its location in a lower ground drainage area. A ditch is determined to be, according to the Merriam-Webster Dictionary on August 18, 2008, “a long narrow excavation dug in the earth (as for drainage).” Ditches are typically found in fields, right of ways, or in older parts of town where they are used for instead of a storm sewer system. Ditches, like defects, were not on a rank scale. It was simply noted in the attribute table whether or not the structure was located in a ditch (Figure 3).

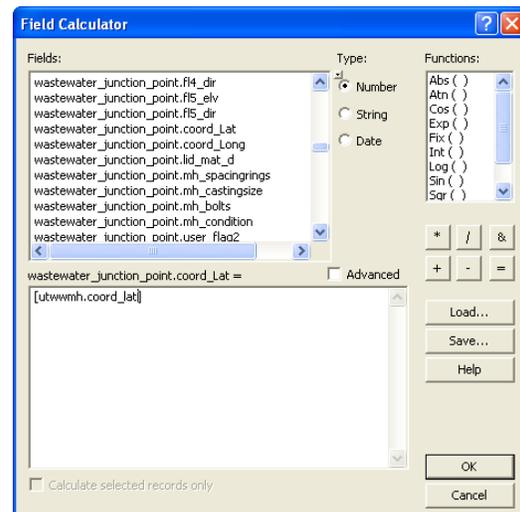
Figure 4. Field Calculator in ArcGIS. This is the tool used to populate the northing, easting, elevation, latitude, and longitude in the attribute table when manipulating the data.

The most useful aspect of the software was its ability to create a shapefile directly from the raw data. Using the DataPro software, the imported raw GPS data was converted into a shapefile. The user flag field was populated by the name field using the Field Calculator (Figure 4). Once loaded into ArcGIS, the data in the shapefiles was directly copied and pasted into the feature class that was associated with that shapefile in the geodatabase. For example, a shapefile named UTWWMH, which is a wastewater manhole, was copied into the wastewater junction point feature class in the geodatabase. Once all the shapefiles had been copied and pasted into their respective feature classes, data manipulation began. The importance of the DataPro software lies in its ability to transform raw GPS data into shapefiles. The other option of importing data would be to use the Xcel table and add

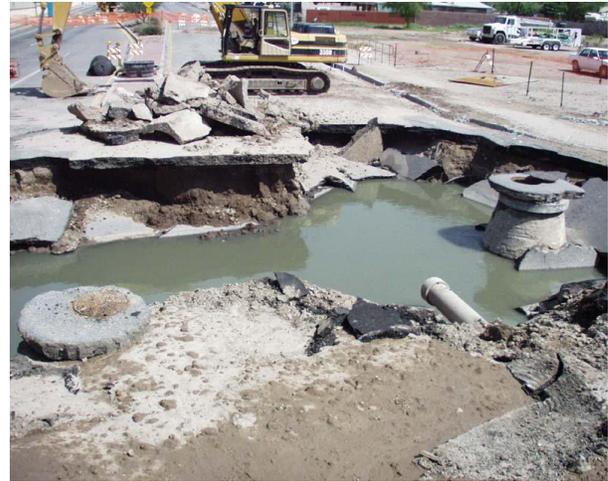
Figure 5A. Sanitary sewer backup can result in a sinkhole. These cause the most monetary damage because roads and utilities need to be replaced.

Manholes with high amounts of infiltration, major structural damage, or serious flow problems were determined to need immediate attention because it is vital for sanitary sewer systems to flow without restraint to prevent backup. Backups can cause sinkholes, flooding, (Figures 5A and 5B), and infiltration of sewage into ground water and other bodies of water before treatment. These occurrences are very costly to repair, not only for clean up, but also for the other utilities harmed.

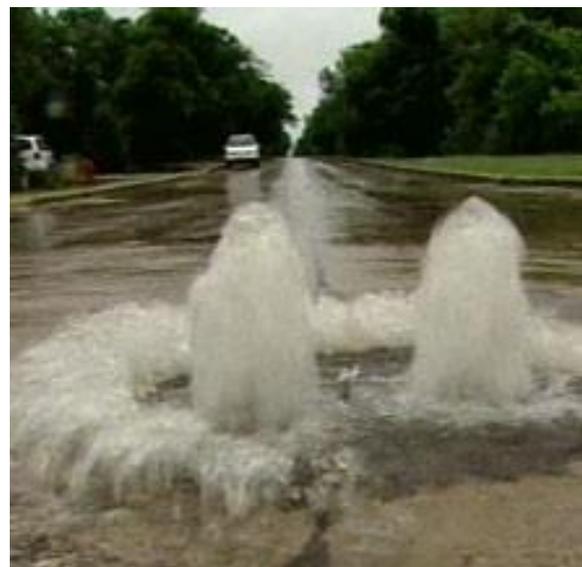
Figure 5B. The manhole is overflowing and flooding because of a system that was over capacity.

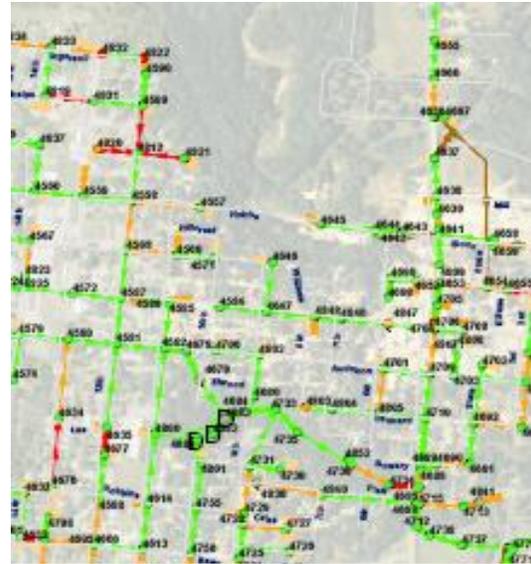
Flow line analysis provided information that 29 pipes had a negative slope (Figure 6). The arrows on the pipes in Figure 6 indicate direction of flow. The pipes were then color coded for clear detection of the area and its overall requirements. The red pipes represent negative slope. The red manholes have a condition of one and require replacement. The green manholes and green pipes are structurally sound with positive flow. The tan and orange manholes and pipes range from two to four, with moderate to low slope. These areas will need to be addressed in the future, but immediate attention is not required the red pipes should be inspected and replaced first. Figure 7 depicts the replacement phase plan. On average, a manhole costs approximately \$500.00 to replace. That does not include cost of construction. The cost to replace 40 manholes for would be approximately \$20,000 plus construction fees. Compared to the million-dollar amount to replace the treatment facility, replacing the manholes is the most cost effective option to keep the wastewater system operating.

Figure 6. Zoomed in portion of the final GIS. Green pipes and manholes are structurally sound with positive flow. Orange and yellow manholes are not in immediate need attention, but should be considered in the long run of replacements. The red pipes have a negative slope and need immediate attention. The red manholes are structurally poor and require replacement.

individual flow lines were analyzed in the attribute to determine which lines were not flowing properly. The analysis also analyzed the onsite data collected to determine which structures were in need of replacement or immediate attention. It was determined that there were forty structures in need of immediate replacement (Figure 6).

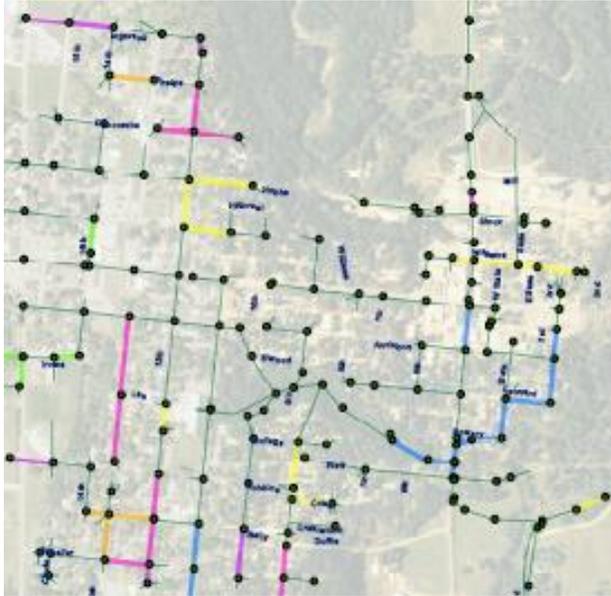
Figure 7. Zoomed in portion of the six-phase recommendation plan to televise and replace pipes. The yellow colored pipes signify the first year televising and replacement plan. The orange and pink colored pipes indicate phases 2 and 3, respectively. Phase 4 is depicted by the purple pipes, while the light blue and dark blue pipes represent phase 5 and 6.

As a result of the analysis, a six-phase plan has been completed to cover all repairs deemed necessary from this study. This six phase plan addressed the issues in a timeline that was relevant to the overall condition of the sanitary sewer. Those in need immediate repair were included in the first phase of the plan, while those repairs that were considered a low priority were pushed back until later phases (Figure 7).

The pipes were color coded to make identifying the phase straightforward. The yellow pipes indicate those pipes which are in dier need of replacement. The pipes with a negative slope, blockage, or other factor that hinders flow will be the pipes that are replaced in the first year phase. The orange and pink colored pipes are those that are deemed for phases 2 and 3, respectively. These pipes will require replacement, but the severity of their problems is less than those of phase 1. Phase 4 is depicted by the purple colored pipes. These, again, are pipes that will need replacement, but attention is not immediately required. Phases 5 and 6 are colored light blue and dark blue, respectively. These pipes are in relatively good condition for the pipes that require replacement. These pipes are not up to grade as a normal pipe would
